Repairing corrosion at a power station

A coal-fired generating station in Arizona required extensive repairs and upgrades. Chemical attack and the subsequent corrosion had to be tackled to prevent a repeat of a catastrophic failure experienced in 1999. The problem was remedied by repairing the effected systems and components and providing a coating to prevent further corrosion.

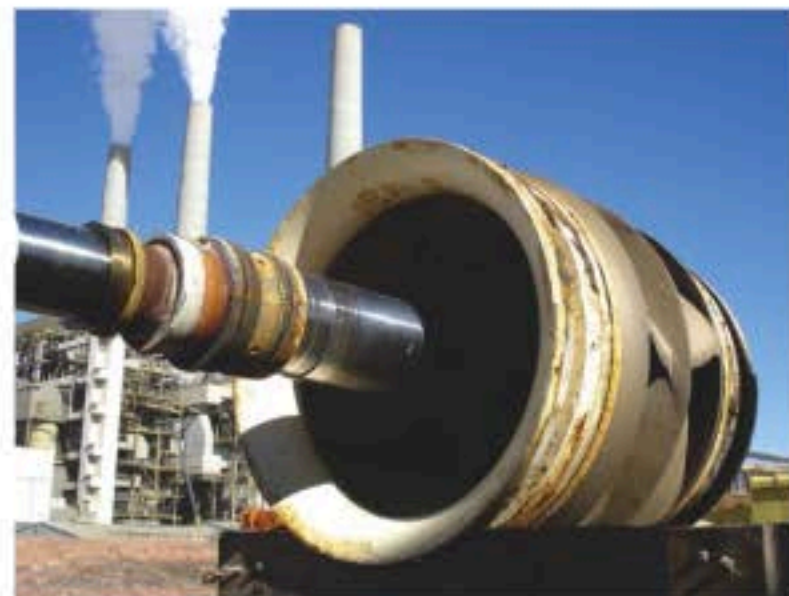
Figure 2. A double suction impeller for one of the cooling tower pumps.

impellers, the amount of wear/damage to vanes and material loss.

"These impellers have been in-service for 30-plus years," adds Smith. "We ordered a new impeller, but unfortunately the manufacturer could not meet our need date so we had to put a bad impeller back in-service. In early 2011, we will begin the replacement of impellers on Unit one, followed by others during future outages. This was the best material option with least cost on new impellers and provided us with technical support that often is non-existent with other vendors."

The Allis Chalmers split case recirculation pump also received a new impeller, wear ring housings and related components. Quadna recommended and used a combination of coatings on the pump and valve. The team suggested and changed the impeller from a nickel aluminum bronze (Ni Al bronze) to stainless steel 316 to further ensure a long service life and more efficient operating dynamics.

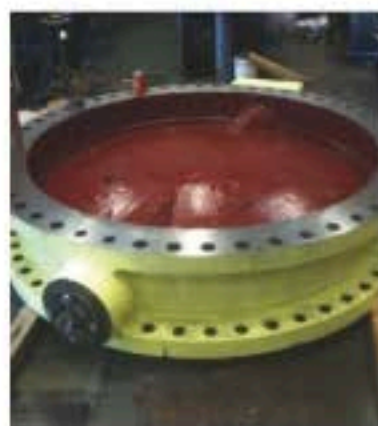
Cooling towers offer a wide range of challenges to maintain good water chemistry. A host of chemicals are required to maintain pH and to keep algae growth to a minimum. These chemicals are not always compatible with the pumps and valves' material of construction. During the major service, repair and overhaul, observations were made; the team was concerned that chemical attack was wrecking havoc on the giant butterfly

valves and pump shaft. The team wanted to ensure the system not only received important repairs and replacements, but that the components could be better protected against aggressive chemical attack.

Figure 3. The Pratt butterfly valve.

In 2008, Smith says it was time for the 66 in Pratt butterfly valve rebuild. The engineering, service and repair team had been monitoring the pump system and components for a number of years including the last several outage overhauls. Through keen observation and ongoing base metal checks and testing for progress of chemical attack, the group determined when to schedule the needed repairs, replacements and system enhancements.

In addition to the pre-determined service and repairs, which typically occur every six years for a major outage and every three for a minor one, the recommendation solutions included coating all of the surfaces where the chemical attack was prevalent to reduce future wear. The coating solution approach was approved by SRP for implementation.

"Quadna put together the valve rebuild and the coating solution to prevent chemical attack on the valve body and internal components," says Smith. "The technical support, proactive response to the needs of NGS and knowledge of this equipment assisted us with respect to our six-year major overhaul intervals run time, and in providing the best solutions to problems and to providing technical support specific to this industry's type of corrosive and abrasive operations, which are inherent to coal-fired generating stations."

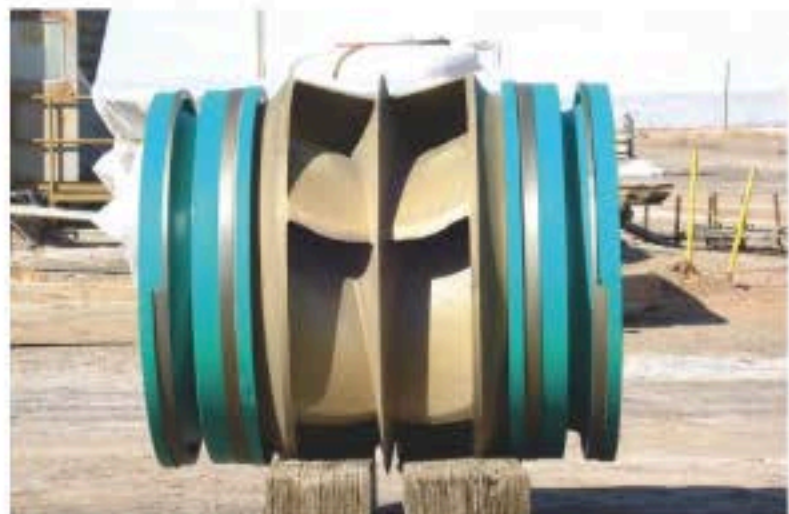
Figure 4. The casting ring bearing prior to installation.

The pump's cast iron casing rings were coated with 3M Scotchcoat 134. The aggressive chemical attack had affected the cast iron housings and base metal, causing the base to lose its competency. The 3M Scotchcoat fuse coat now helps prevent hydrochloric acid from destroying the rings (and the valves).
