Pumps and Systems Success Story of the Year 2010 Honorable Mention

During a planned nine-week outage at SRP's 2,400 MW Navajo Generating Station (NGS) in Page, Ariz., Quadna tackled the problem of corrosion affecting the 66 x 78 in. split case cooling tower recirculation pump and 66-in. diameter butterfly valves. The pumps and valves had corroded due to exposure to the various harsh chemicals that maintain good water chemistry in the cooling tower.

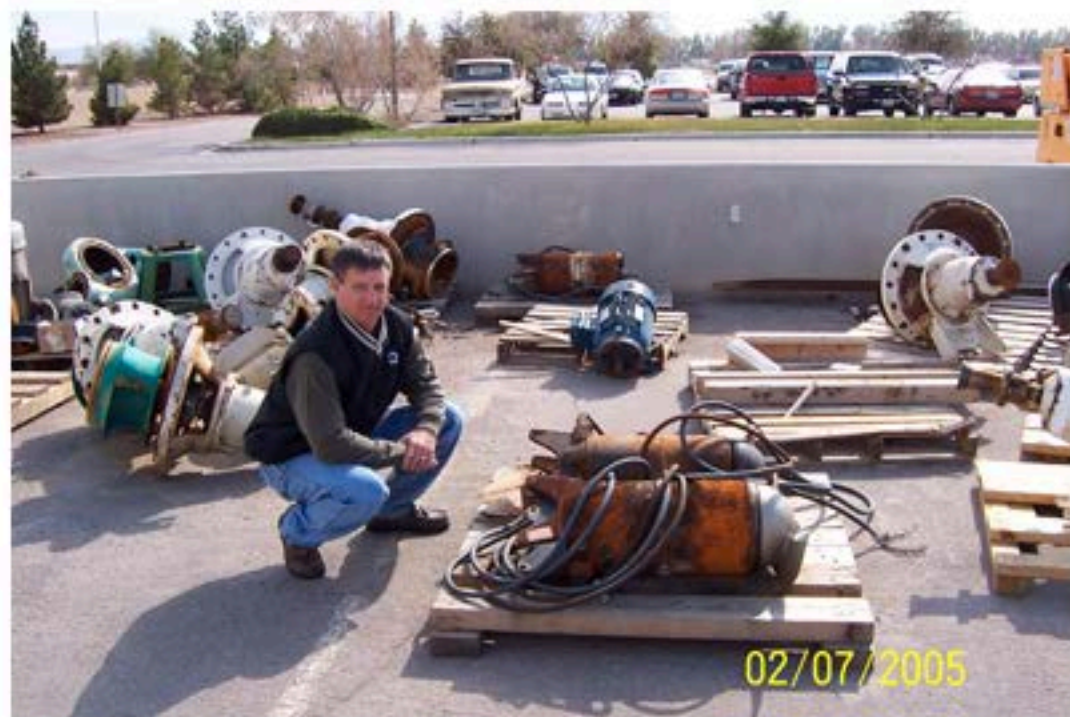
According to Dana Smith, planner/scheduler for SRP, Vic Lundberg (shown above) "put together the valve rebuild and the coating solution to prevent chemical attack on the valve body and internal components."

The two butterfly valves, each of which weighed 12,000 lbs, were also rebuilt. They had been in service for more than 30 years.
